Scorpion TMA Post Impact Survey Measurements

TITLE:
TMA Post Impact Measurements and Survey

SIZE B	DRAWING NO. 1086	REV E1
------------------	---------------------	------------------

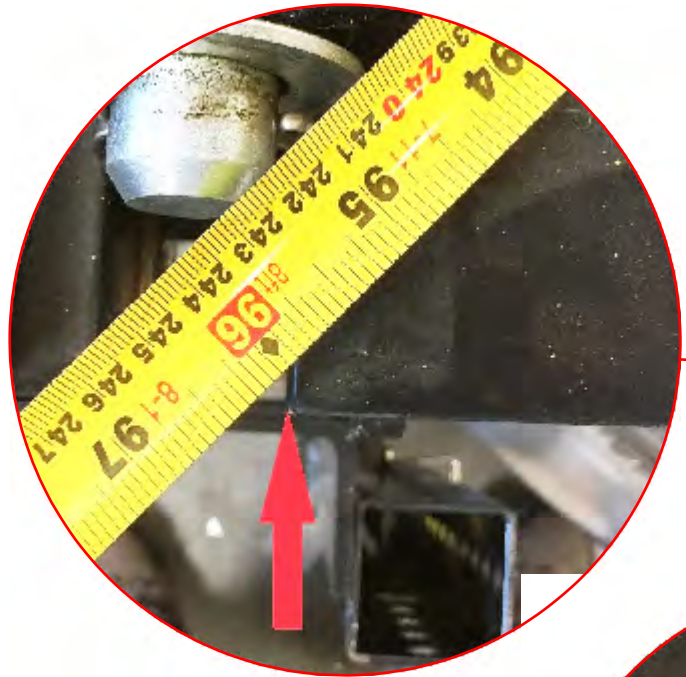
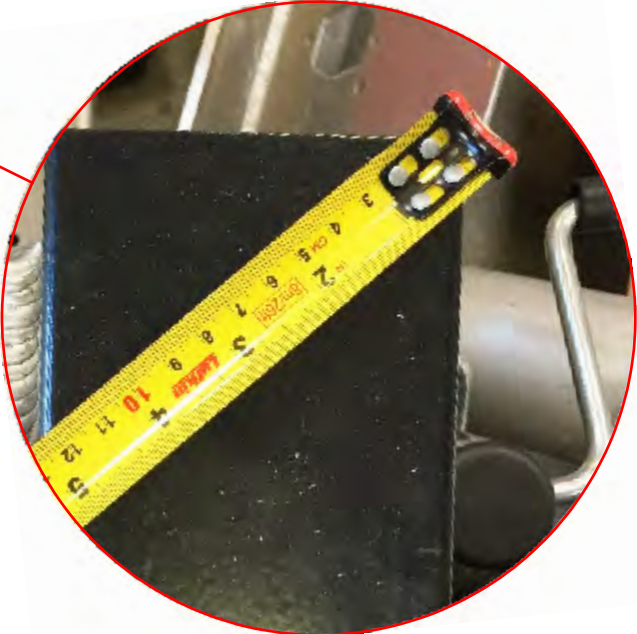
Strut Section: Survey Measurement Closeup Views

Closeup View of Measurements E & F

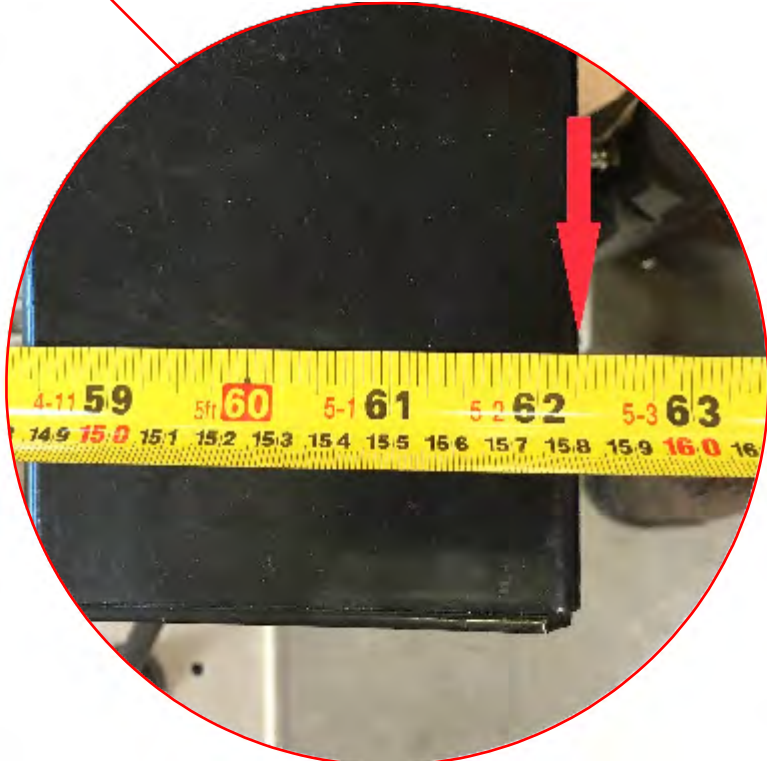
Closeup View of Measurements G & H
